ATTACHMENT F - 11/06/2023 Photos

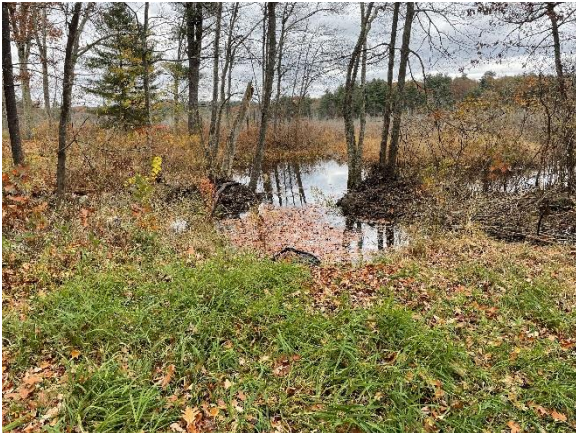
Photo 1: Upstream view looking east-northeast from Maple Avenue.

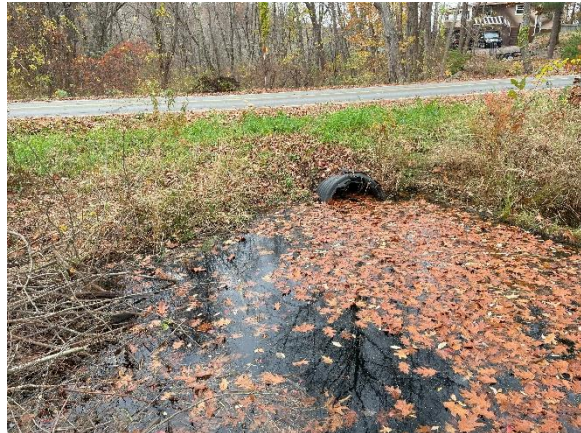
Photo 2: View of upstream culvert inlet, looking west-southwest from the rock wall upstream of Maple Avenue.

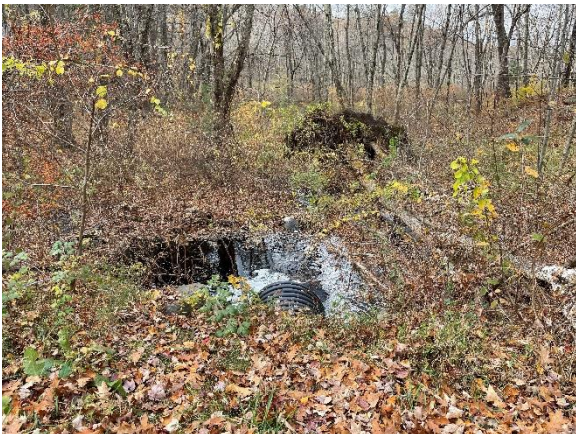
Photo 3: Downstream view looking west-southwest from Maple Avenue.

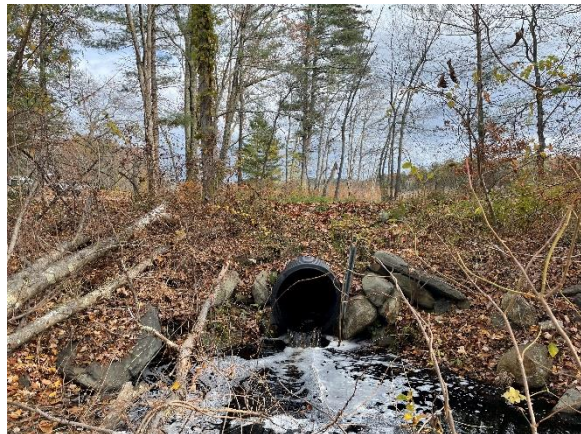
Photo 4: View of downstream culvert outlet, perched $\pm 5'$, looking east-northeast.

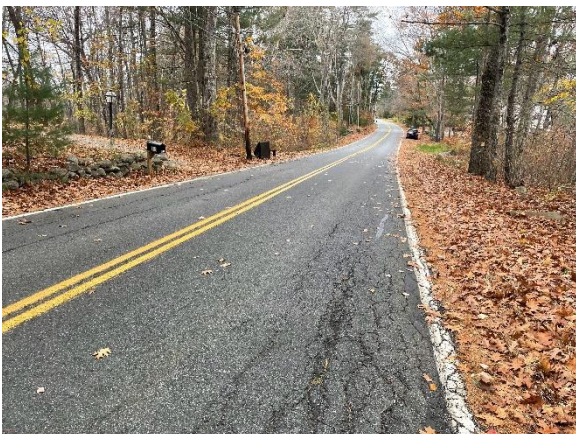
Photo 5: View looking north along Maple Avenue toward the crossing site.

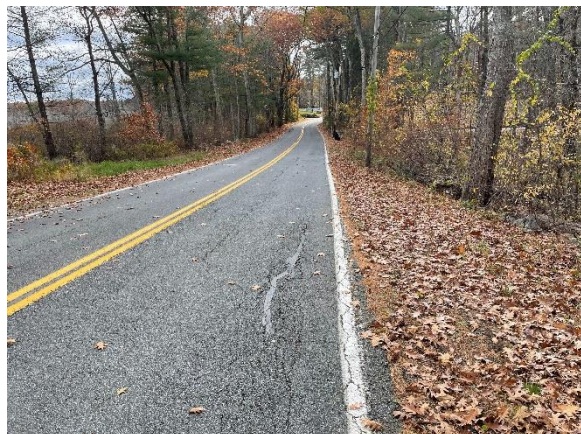
Photo 6: View looking south along Maple Avenue toward the crossing site. The existing culvert is approximately six feet beyond the utility pole on the right side of the photo.
